TS130V - Omron relay removal/replacement

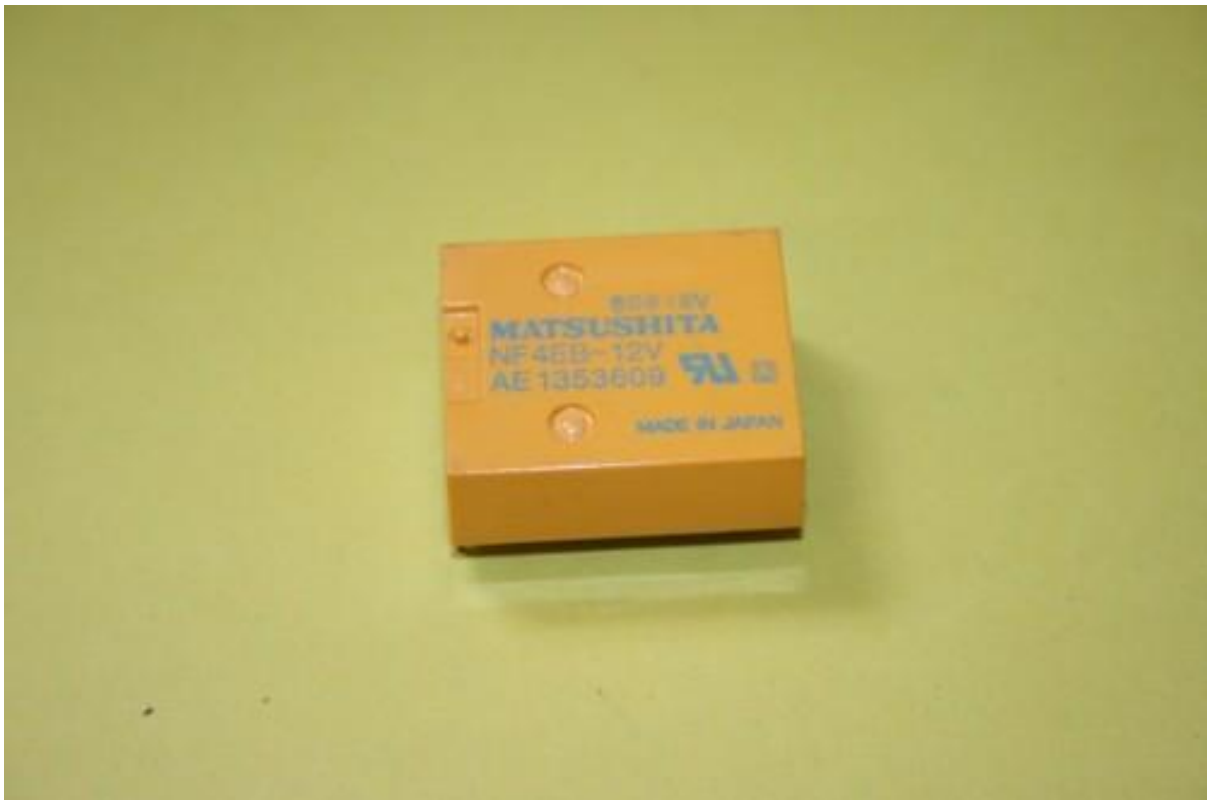
The replacement relay is a like for like and is listed online as a MATSUSHITA NF4EB-12V

Below is a picture of what it looks like

These relays can be bought online; it's a case of searching for them. It is a direct one for one swop. The pinout is exactly the same as the Omron it is replacing.

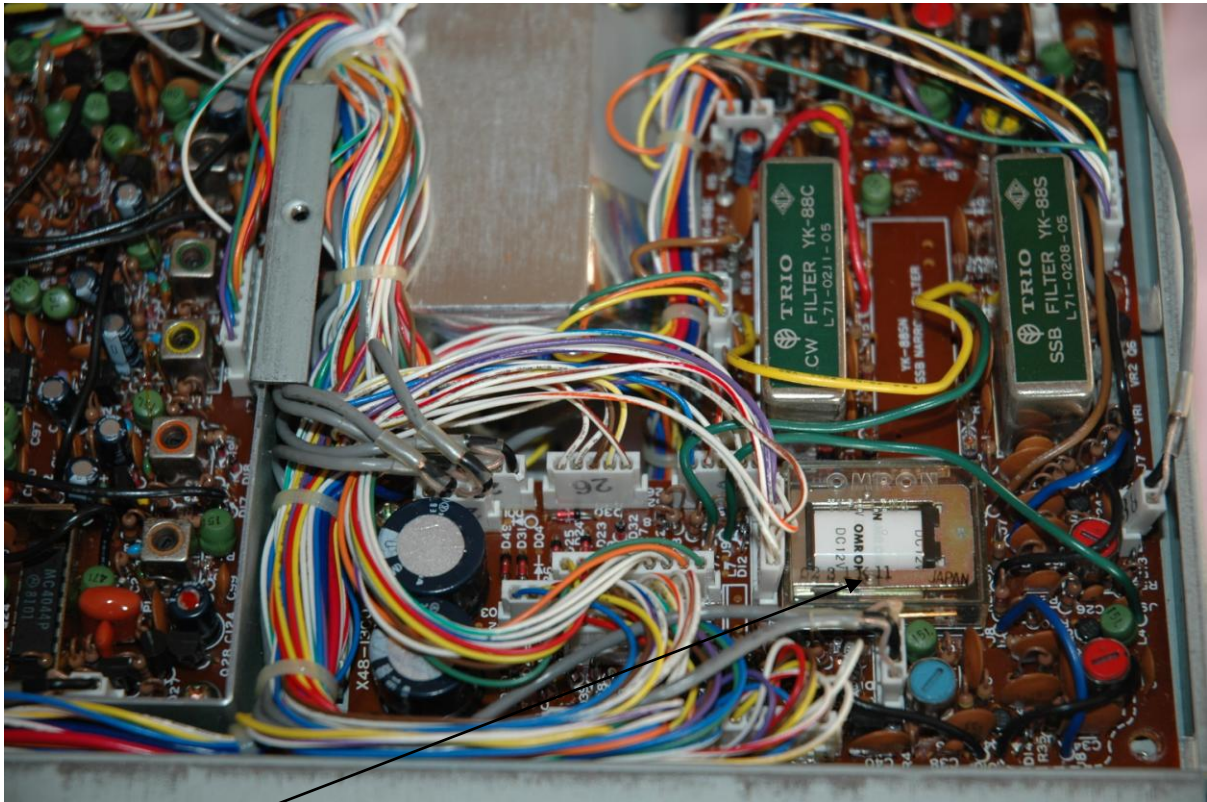
Relay on the IF board.

The board upon which the work is to be done is the IF Unit board marked X48-1300-00.

It is accessible when you take the **bottom cover** off; it is situated to the left hand side if you are looking from the front of the transceiver.

In the picture above, (taken from the rear of the rig) you will see the relay in the bottom right hand corner. It is very neatly set in there and it may initially cause some concern when you see how it is boxed in, but fear not.

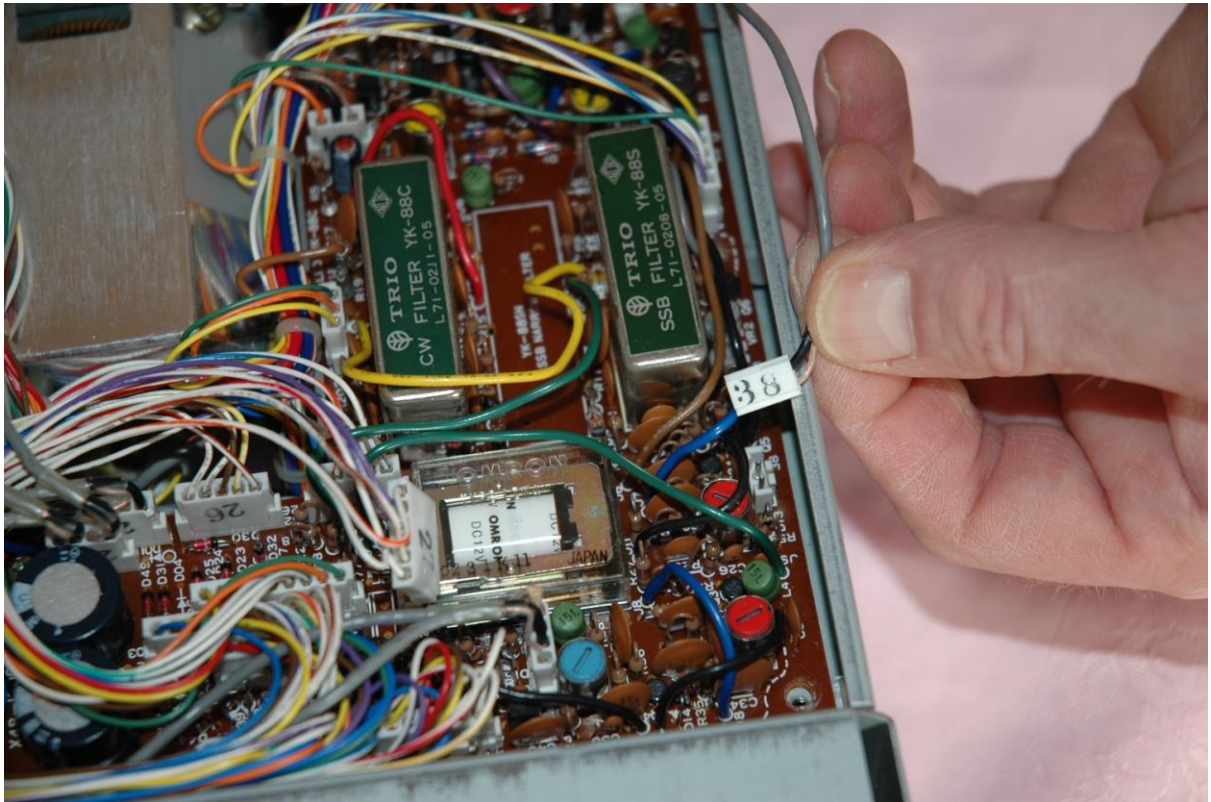
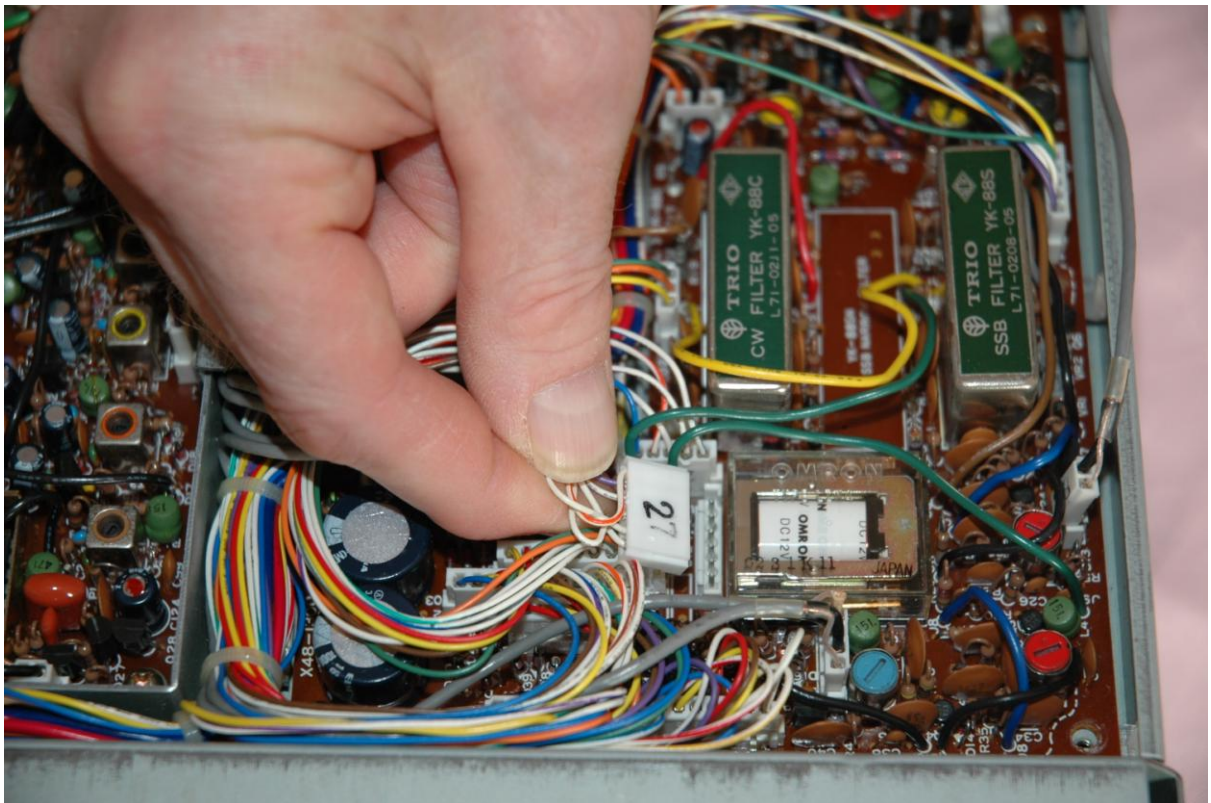
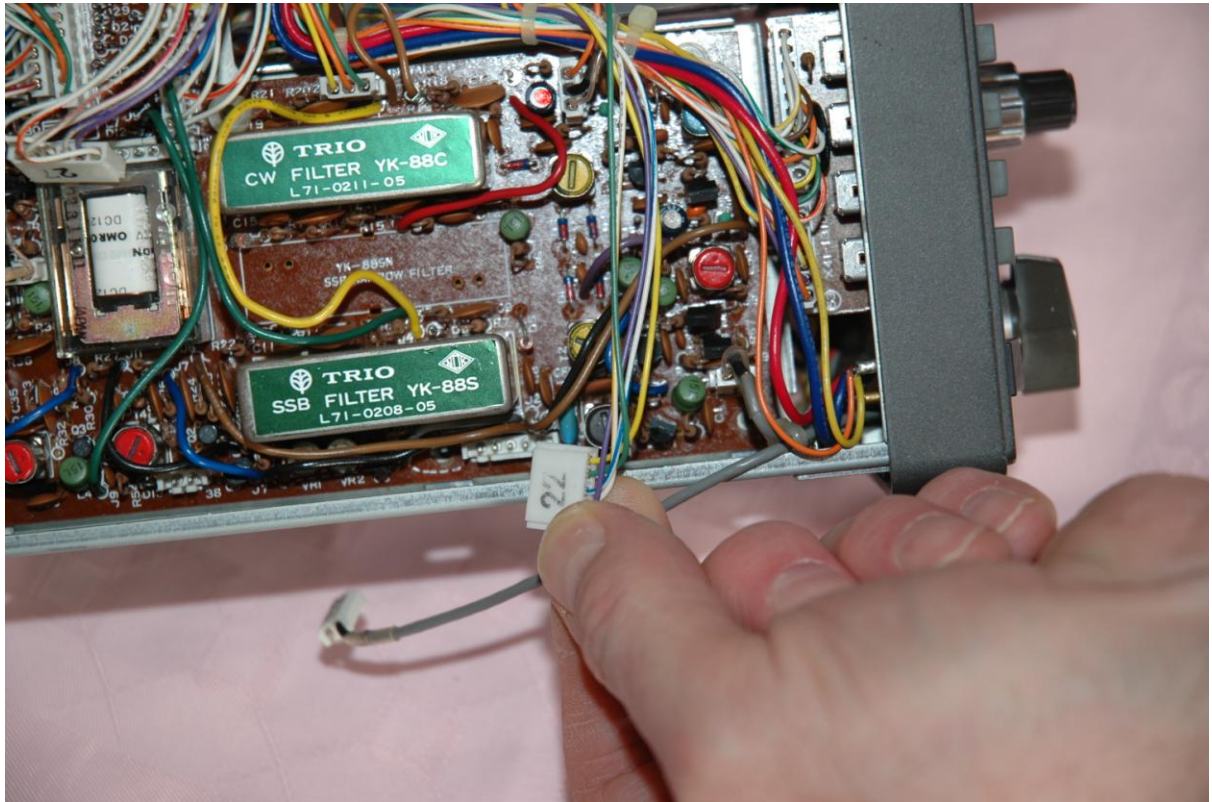
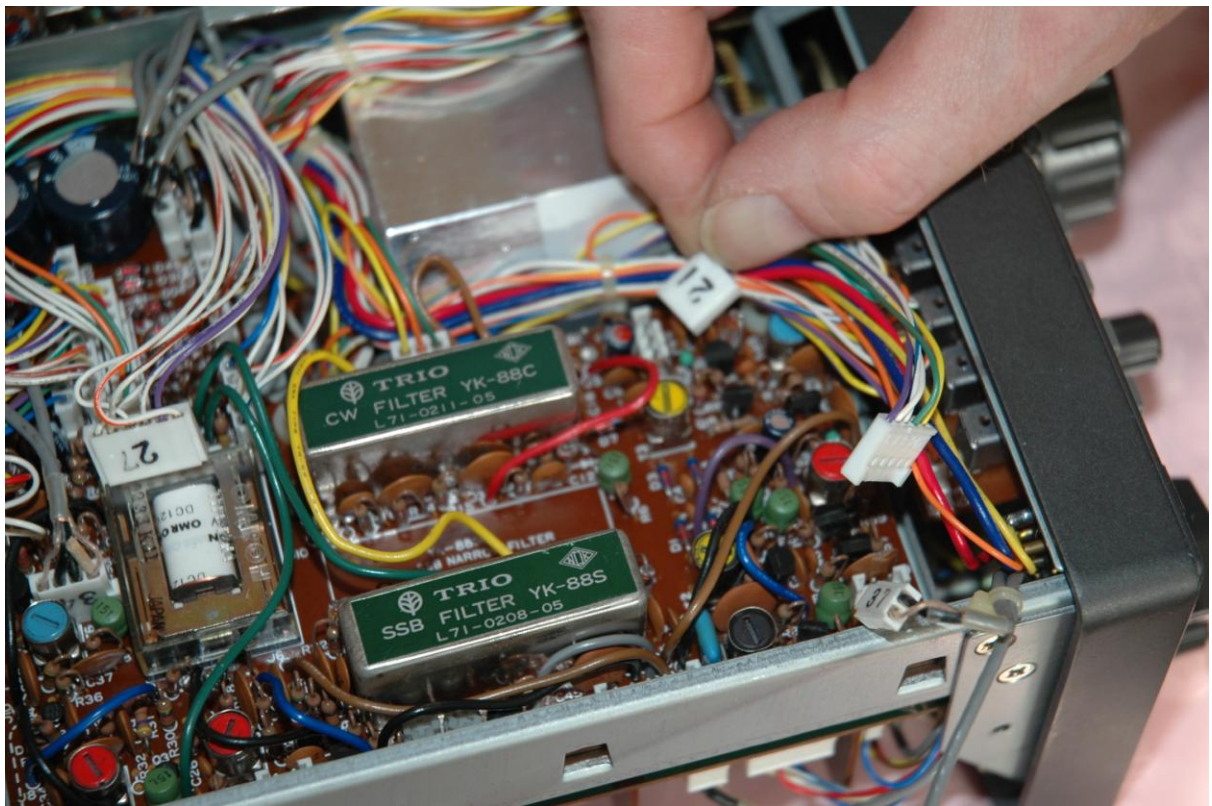
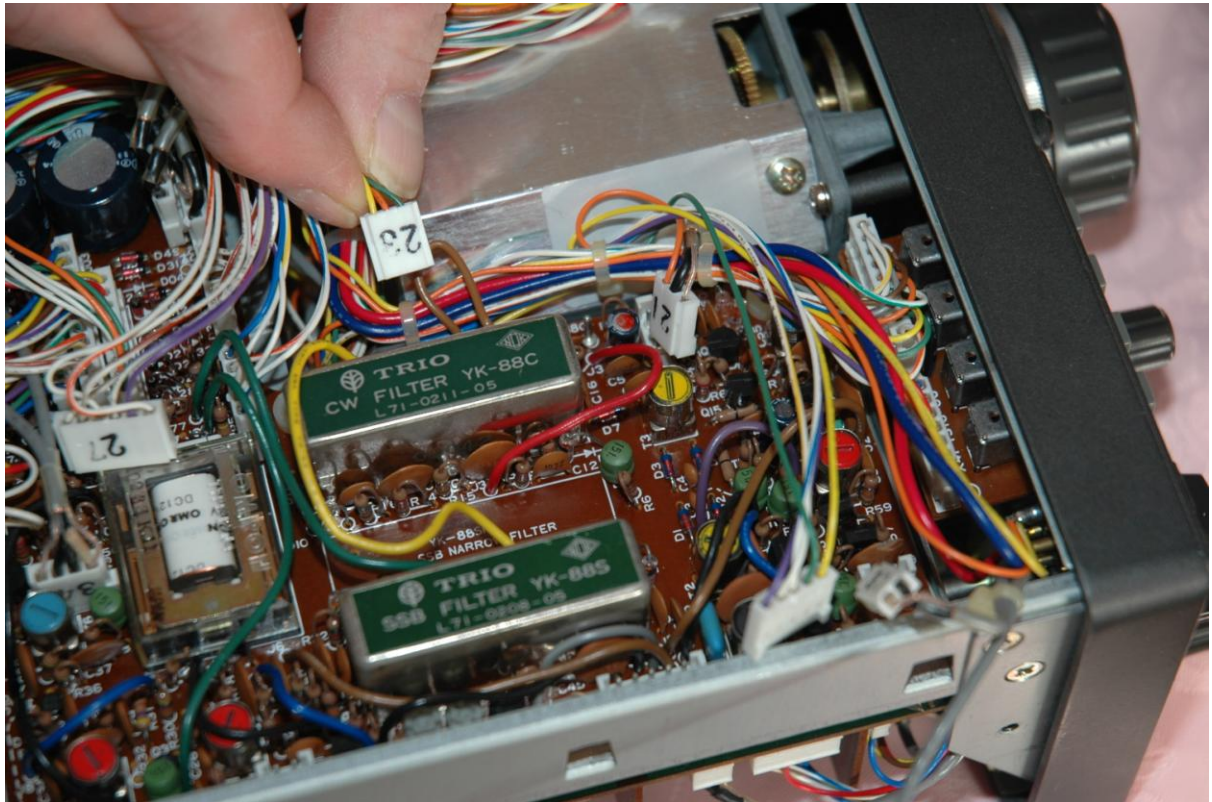
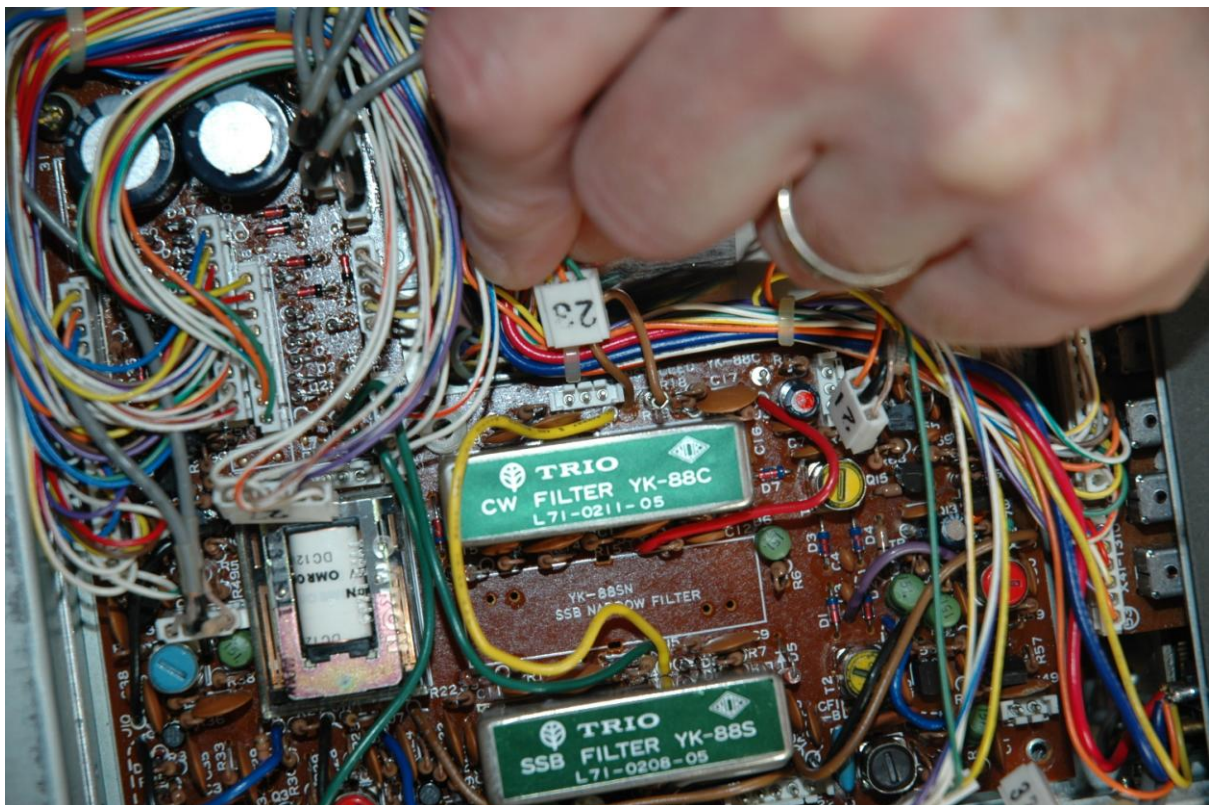
- a. Remove both the top and bottom covers of the rig by unscrewing all the philips head screws. There are 4 screws in the middle of the top cover which you do not remove. These hold the speaker in place. Remember when you lift the top cover lid, the speaker is attached to the board below so be careful unplugging this.
- b. Ensure you keep all the screws together . I put all mine in an egg cup so as not to lose any.
- c. There are a number of cable looms and miniature coaxial cable fittings which I strongly advise you to identify prior to separating from the parent socket mounts. I ended up photographing them as shown below. You will see that the female socket heads on the various looms are numbered. Take note of these as this will help keep you right.
- d. There are a number of screws holding the IF board in situ and these need to be removed in order to free up the board.

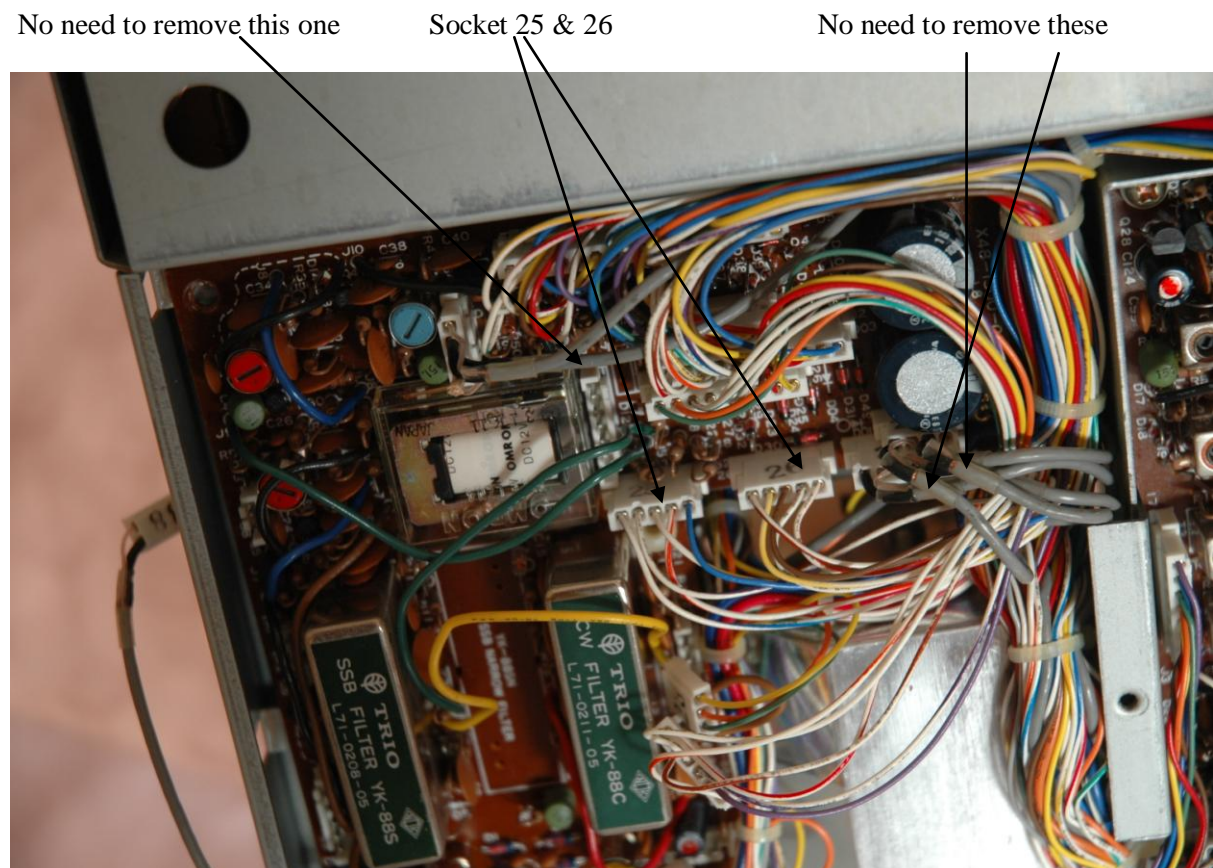
In the top part of the picture below you will see a number of arrows inserted. These coaxial sockets did not need unplugging prior to working on the board. The last two wiring looms I did have to remove were as shown in the picture below. They are marked 25 & 26. Just to the right of the relay.

Undo all the IF board screws carefully and store them safely. Note that some of the board screws vary in length so you will need to be sure you know which screw goes where with regard to replacement.

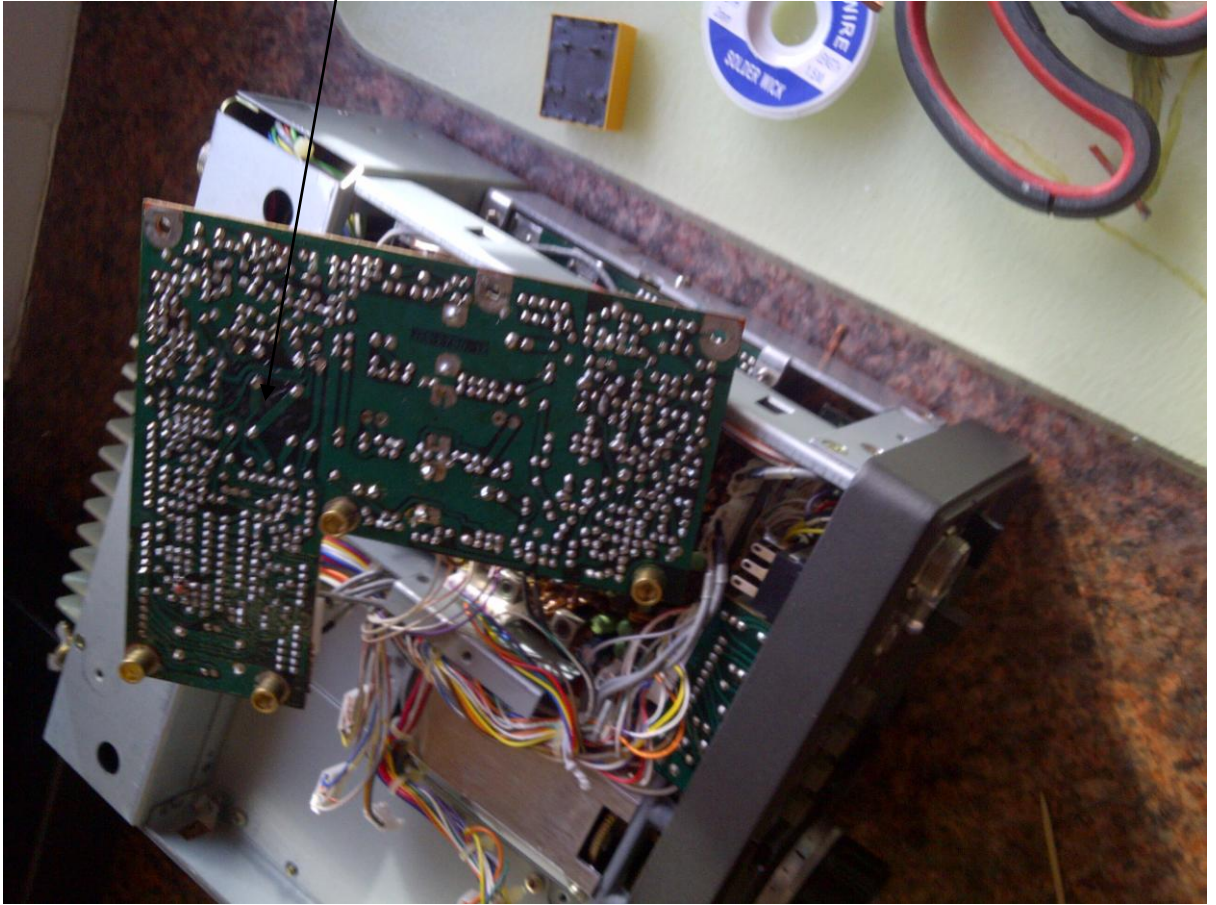
This is the relay underside.

- e. Having identified the various looms and coaxial connections, unplug them and ease the IF board out of its mounting. Tilt it on its back. With the various looms released, it will easily flip over to allow you to identify the soldered relay pin points.
- f. May I once again say be very very careful unplugging sockets. As I said earlier and repeat, the rig is of a good age and therefore it will not take much to cause damage.
- g. Now comes the interesting part; there are 15 pins on the Omron relay and these will have to be desoldered. I recommend a solder sucker pump and desoldering wick to achieve the best results. The desoldering pump really does work very well. You will want to have all solder removed around every pin and then very gently, rock the relay and it will come away.

- h. **Replacement;** ensure all the upright pinheads on the new relay are straight up and do not tilt to one side or are bent. The great news is that the relay will only fit in one way. That's a blessing. Drop it in and go to work achieving a good solder joint on each pad. Be careful not to drip solder on to other tracks or pads.
- i. Having soldered all 15 pins, check your work carefully.
- j. In the same way as you removed the various wired loom socket plugs, place them back in their respective sockets ensuring they are seated correctly. Likewise, Reinsert the mini coaxial plugs on to the board.

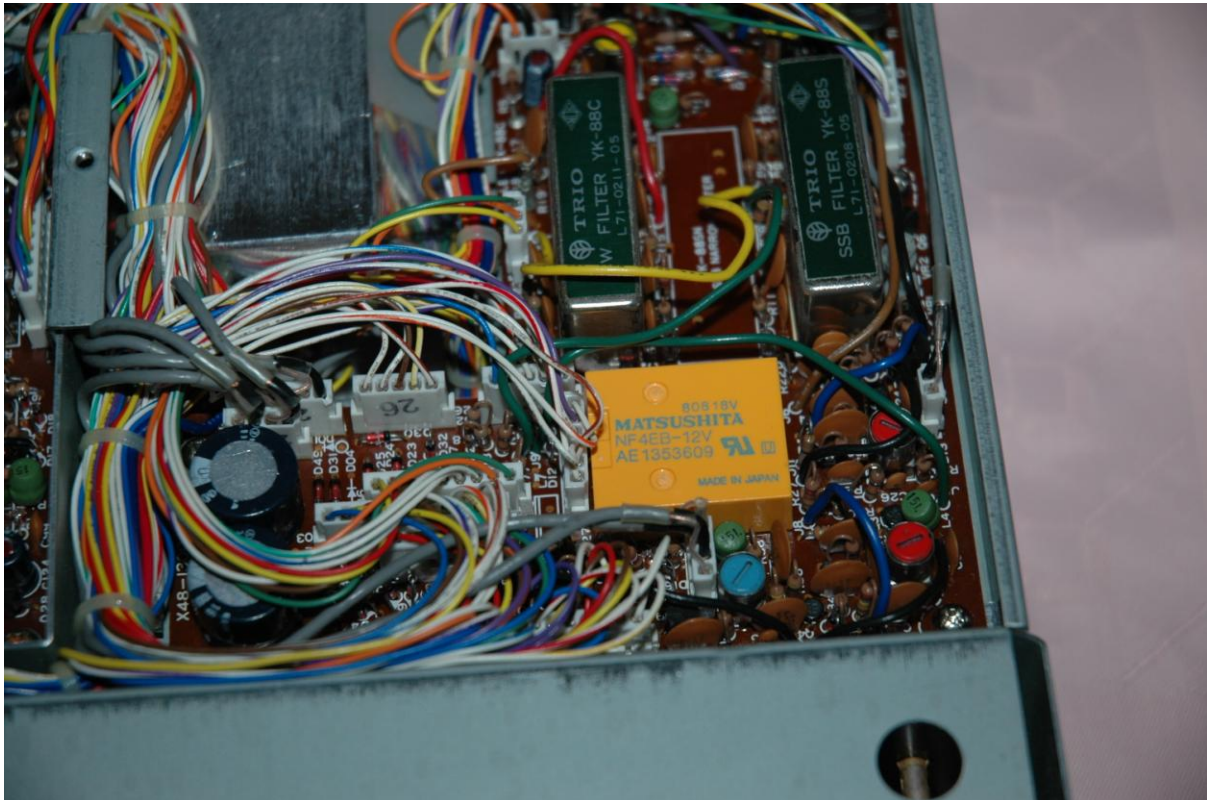
I am extremely pleased that I came across no issues whilst carrying out this work and the rig came to life without a hitch. The transmit/receive relay works perfectly.
